Manhole Inspection Summary

Manhole # S41U__023MH

Insp Date: **10/9/08 11:46 AM**

Location Address: **900 e fort ave**

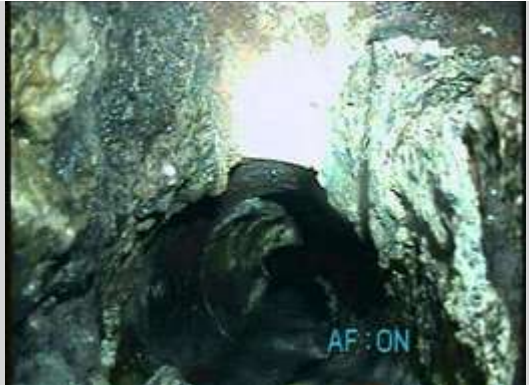
12 O'Clock Outflow

8 in. Circular Gravity Sewer
Pipe Out @ 12 O'Clock

Pipe Material: **Clay** ☐ Pipe Lined

Invert Depth: 11.16 (ft.) Flow Characteristics: **Fast**

Deposits: ☒ None ☐ Mud ☐ Sludge ☐ Debris ☐ Grease

Infiltration: **None** Pipe Seal Cond: **Unknown**

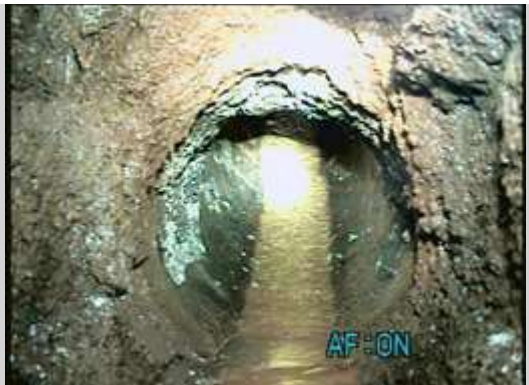
6 O'Clock Inflow

8 in. Circular Gravity Sewer
Pipe In @ 6 O'Clock

Pipe Material: **Clay** ☐ Pipe Lined

Invert Depth: 11.00 (ft.) Flow Characteristics: **Slow**

Deposits: ☒ None ☐ Mud ☐ Sludge ☐ Debris ☐ Grease

Infiltration: **None** Pipe Seal Cond: **Unknown**

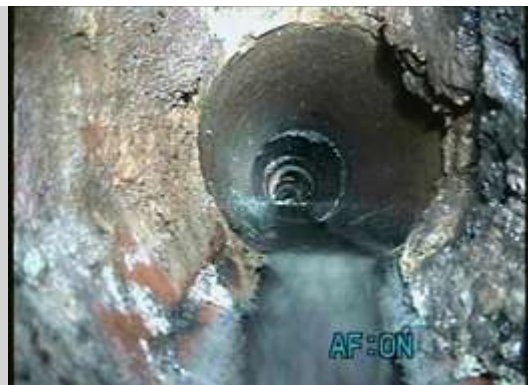
9 O'Clock Inflow

8 in. Circular Gravity Sewer
Pipe In @ 9 O'Clock

Pipe Material: **Clay** ☐ Pipe Lined

Infiltration: **None** Pipe Seal Cond: **Unknown**
